BATHYMETRIC SURVEY AND DATA PROCESSING OF IRON GATE I STILLING BASIN

HE Đerdap

July, 2014

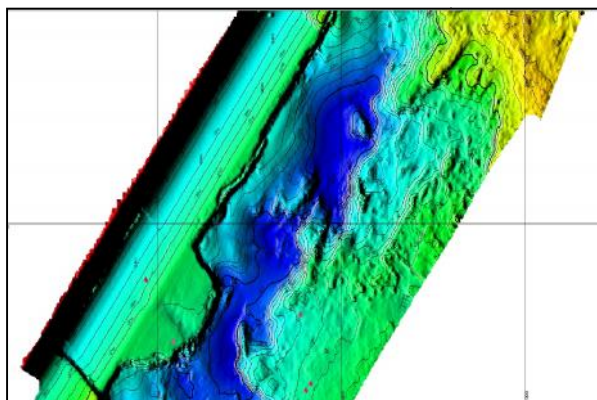
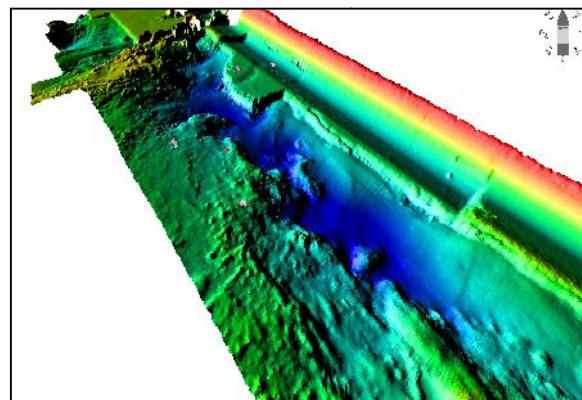
Bathymetric survey with multibeam echo sounder of an area, 400mx200m, where erosion occurred.

Post processing of the survey data and detailed 3D model creation in order to define real scale of erosion.

Erosion of the Iron Gate I stilling basin was detected earlier and the client wanted to determine the real scale of the damage and to decide if construction works for recovery should be executed.

Multibeam bathymetric survey was intended to determine damage caused by erosion
