BATHYMETRIC SURVEY OF SELECTED LOCATIONS ON THE DANUBE RIVERBANK IN THE AREA OF “DJERDAP I” ACCUMULATION

Project objectives

Bathymetric survey with multibeam echo sounder on three locations close to right bank of Danube river.

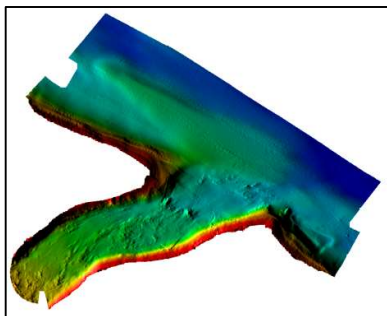
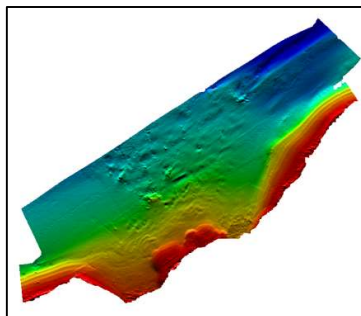
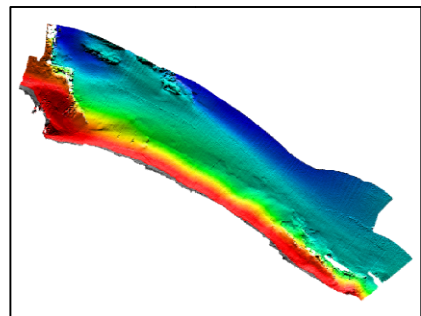
Post processing of the survey data and detailed 3D model creation in order to define real conditions of riverbank.

During exploitation of hydropower of Djerdap I accumulation in the last decades the erosion of riverbank has occurred. The client wants to determine the real scale of the erosion on three selected location.

First location was close to the Old fortress Golubac, second was in the village Tekija and the last location was close to the Đerdap I dam at the river Kosovica confluence.
